AFFTC-TD-69-4

FLIGHT PLANNING AND CONDUCT OF THE X-15A-2 ENVELOPE EXPANSION PROGRAM

JOHNNY G. ARMSTRONG
Aerospace Research Engineer

JULY 1969

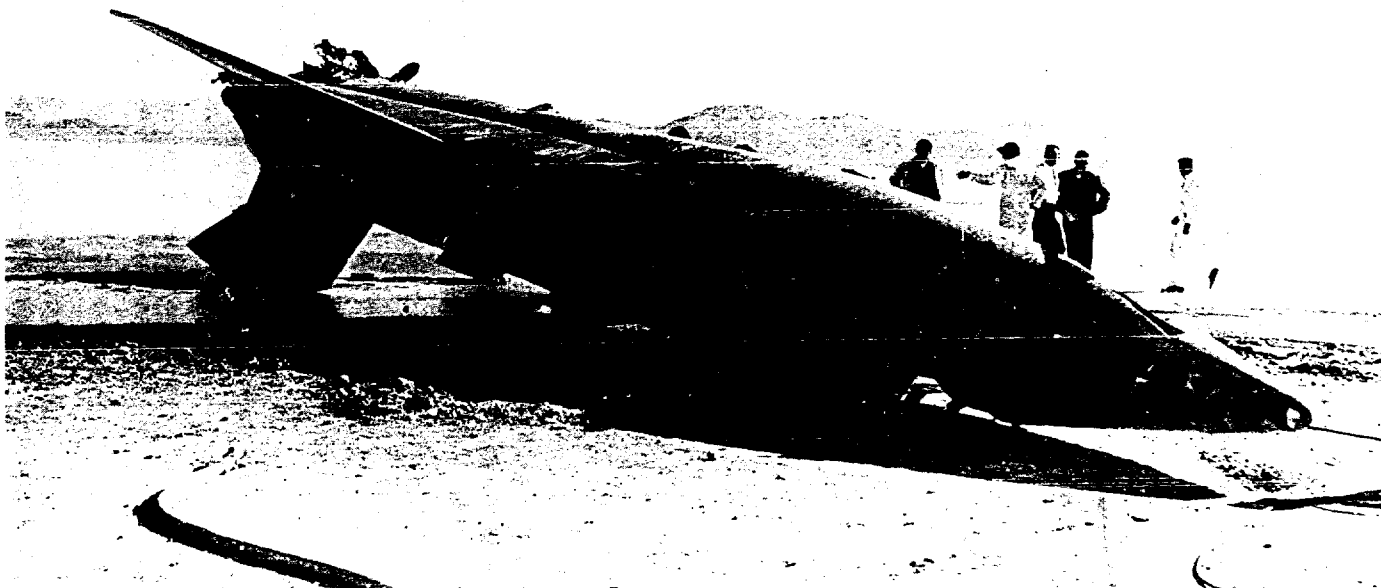
Figure 1 AIRCRAFT DAMAGE - FLIGHT No. 2-31-62

During the latter part of 1962, flight tests were conducted to verify a predicted improvement in lateral directional handling qualities at high Mach numbers and high angles of attack with the lower movable ventral fin removed. The thirty-first flight of X-15-2 on November 9, 1962, was planned to further investigate the aircraft's ventral-off handling qualities. However, during this flight only 30-percent thrust could be obtained from the XLR99 engine as a result of a throttle control failure. An emergency landing was attempted at the launch lake (Mud Lake) in accordance with preplanned alternate procedures. At touchdown the left main gear strut collapsed, causing the aircraft to skid sideways and turn over on its back. The gear structural limit was exceeded primarily because landing flaps failed to extend. The aircraft suffered extensive damage (figure 1). The aircraft had accumulated a total free flight time of 4 hours, 40 minutes, 32.2 seconds at this point.

A decision was made to rebuild the aircraft in order to complete the planned experiments and to incorporate modifications to increase the performance of the aircraft and thus allow it to be used as a testbed for a hypersonic ramjet engine. Approval was given under Contract AF33(657)-11614 for North American Aviation, on May 13, 1963, to proceed with repair and modification of the aircraft at a cost of approximately 5 million dollars. The modified aircraft (figures 2 and 3) was returned to Edwards AFB on February 19, 1964, and made its first flight June 25, 1964.

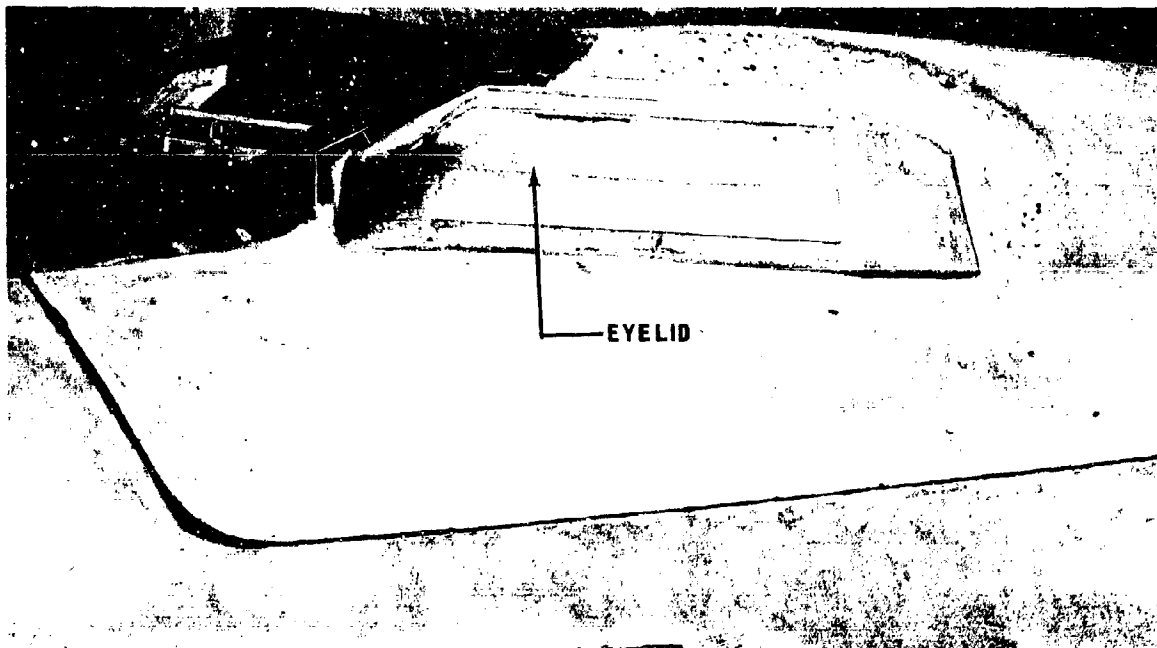
Figure 48 LEFT CANOPY

The condition of the canopy after the flight is shown in figures 48 and 49. The extent of the "fogging" on the unprotected left windshield due to redeposit of the ablation products may also be observed.

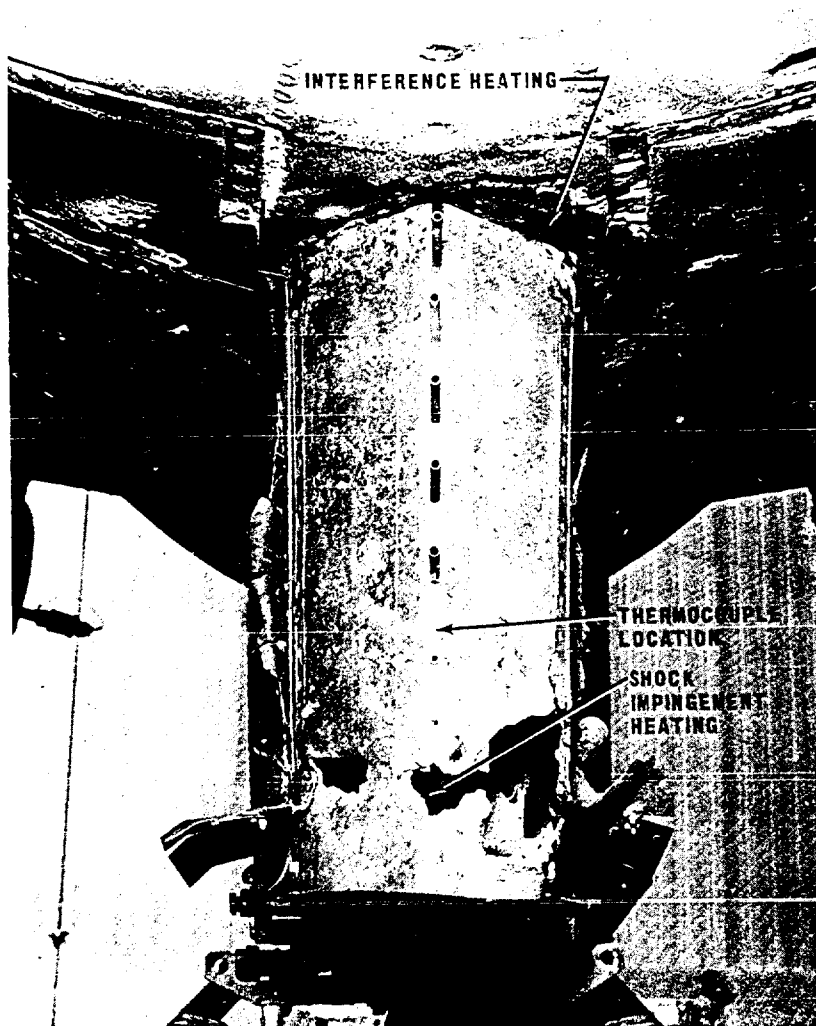
Figure 51 PYLON HEAT DAMAGE—FRONT

The most severe melting damage occurred near the bottom of the ramjet pylon where shock waves generated by the ramjet spike tip, spike flare, cowl lip and bottom pressure probe were assumed to have intersected (figures 51, 52, and 53). A postflight thermal analysis of the heating in this area was made using the recorded temperature from the thermocouple located at the leading edge of the pylon and the observed heat damage as a guide. The measured temperature indicated a low value (less than 0°F) until approximately 145 seconds after launch when a rapid rise in temperature occurred, indicating that the ablative material had burned

Two areas of high heating due to flow interference were the pylon/fuselage junction and the ramjet cowl lip. A reasonable temperature profile for the indicated damage was also obtained by increasing the undisturbed heat-transfer coefficient by a significant factor. The calculated temperature due to interference heating of the ramjet cowl lip exceeded the melting point of the 4130 steel (2800 degrees F) for a short time causing the melting damage shown in figure 54. A complete analysis of this subject may be found in reference 7.
